Home Inspection Report

Property Address:
Lakeside Cir
Sunrise FL 33326

Front Elevation

Date: 2/18/2018	Time: 02:00 PM	Report ID:
Property: Lakeside Cir Sunrise FL 33326	Customer: Fernando Aluma	Real Estate Professional: Monica Mendes

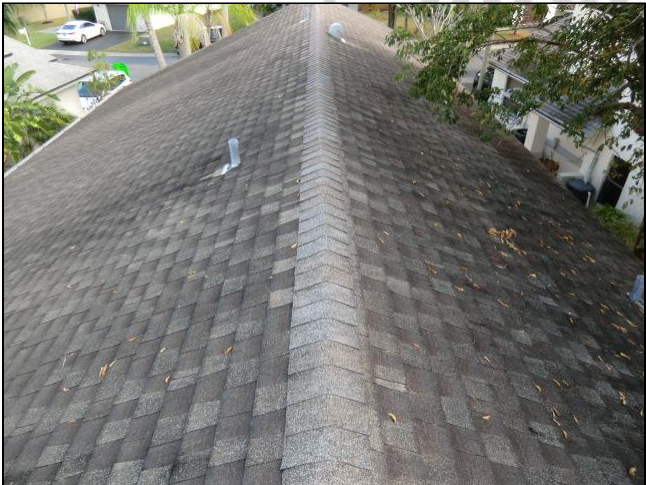
1.0 (1) Good Condition. Roofing permit done in May 23, 2005

Shingle roofing

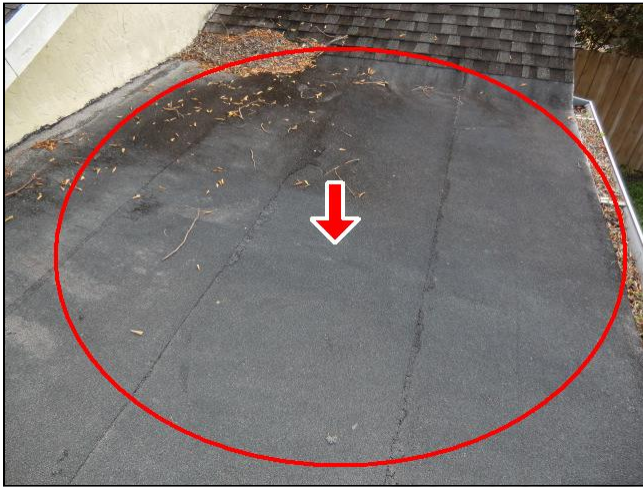
1.0 (2) Defective

Rolled roofing shows some deterioration at the rear of home. I recommend to protect the rolled roofing with a waterproofing elastomeric sealant coating to prevent leaks and extend remaining life. A qualified licensed contractor should inspect and repair or replace as needed.

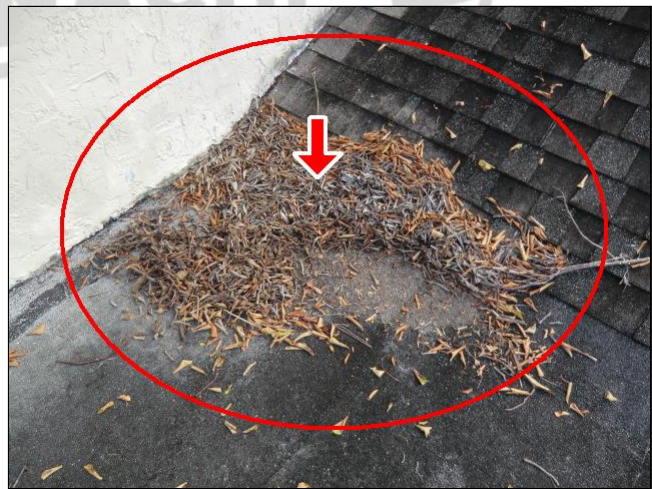
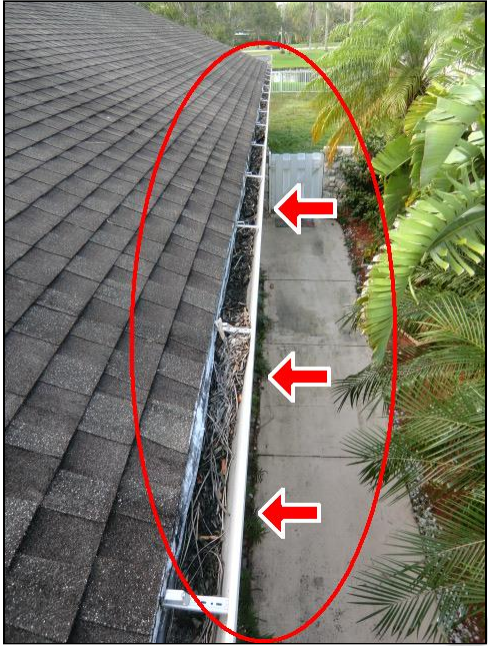
1.3 (2) Defective

The gutters are full of debris in areas and needs to be cleaned. The debris in gutters can also conceal rust, deterioration or leaks that are not visible until cleaned, and I am unable to determine if such conditions exist.

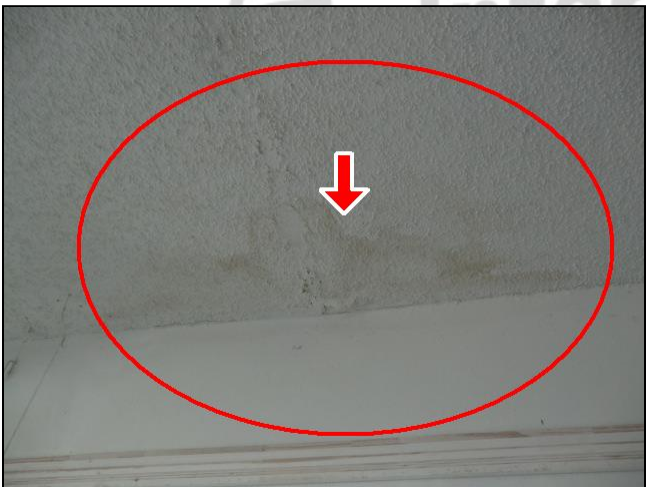
3.0 Defective

The Texture on the ceiling reveals a light stain which appears from a water leak. Stain appears old at the garage. While this damage is cosmetic, it needs to be repaired. A qualified person should repair or replace as needed.

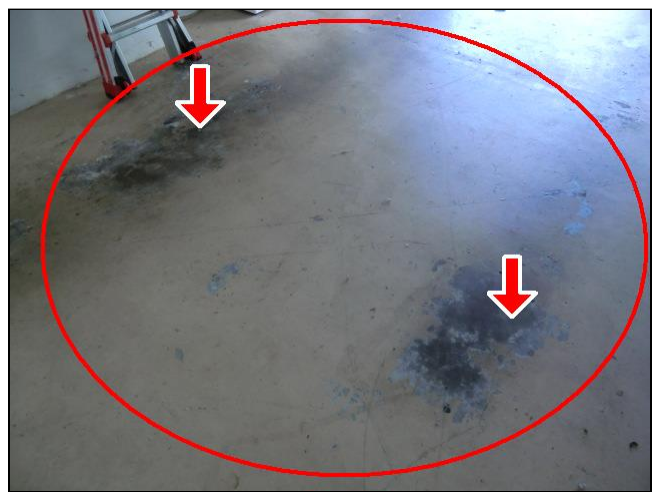
3.2 Defective

The concrete floor of garage is peeling paint. A qualified licensed contractor should inspect and repair or replace as needed.

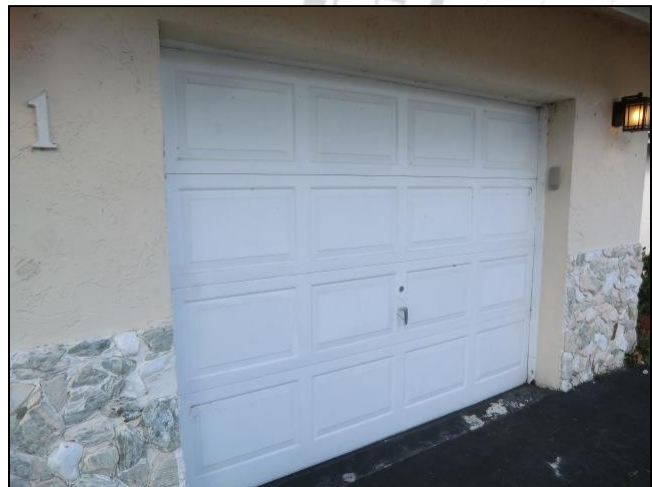
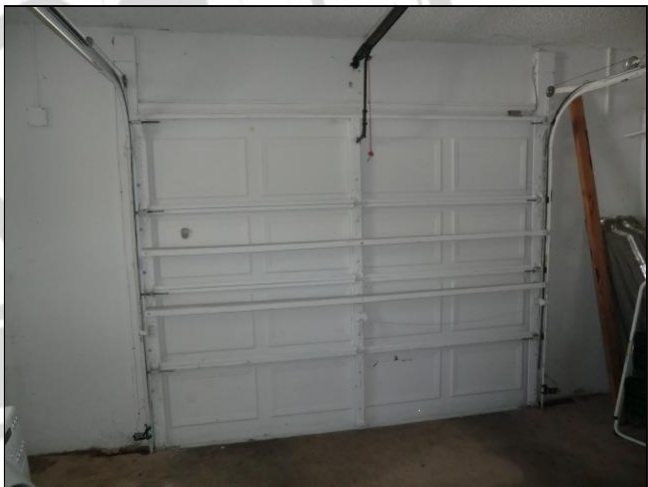
Metal garage door. Not impact

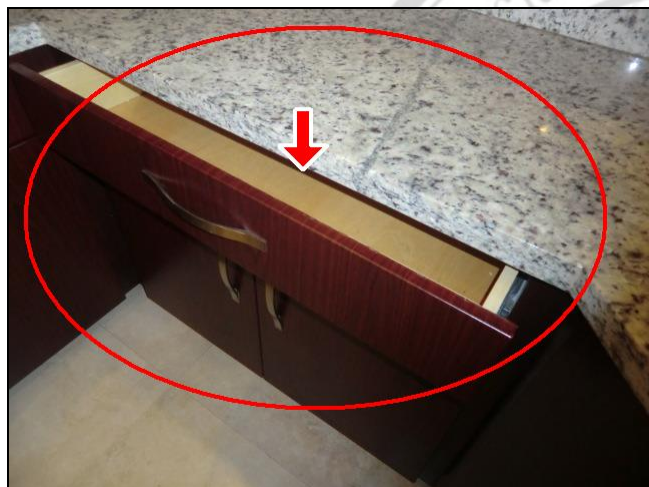
4.5 Defective

Drawer track does not work smoothly (left of sink). This is a cosmetic issue for your information. Recommend repair or replace as necessary.

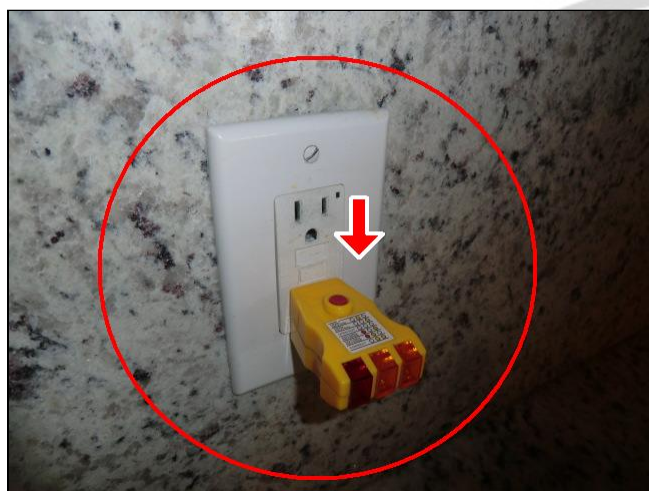
4.8 Defective

At least One GFCI (Ground Fault Circuit Interrupter) outlet at the kitchen did not work or there is no power to outlet. Electrical issues are considered a hazard until repaired. I recommend repair as needed.

Estimated cost to repair or replace around \$50-\$150. Call contractors for estimate.

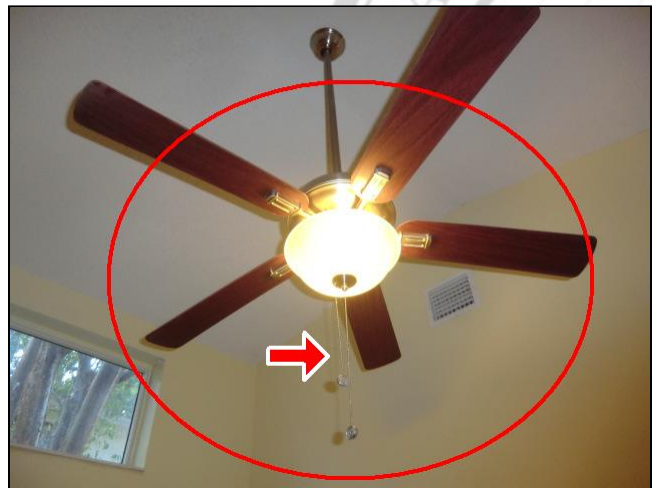
5.6 Defective

The ceiling fan has the switch chain stuck at the Dining room. A qualified licensed contractor should inspect and repair or replace as needed.

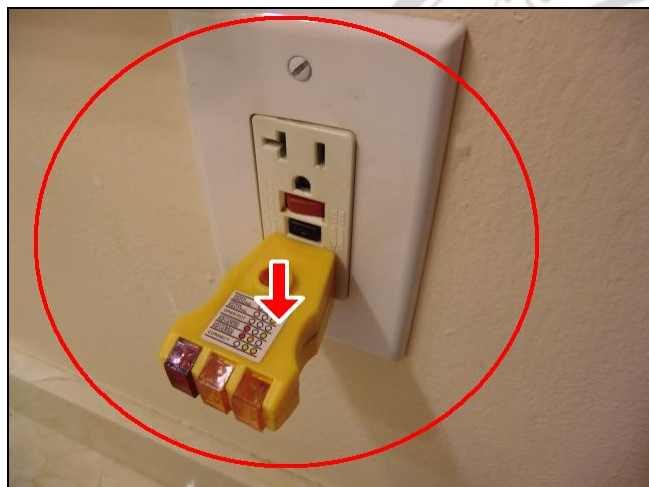
6.5 Defective

At least One GFCI (Ground Fault Circuit Interrupter) outlet at the hall bath did not work or there is no power to outlet. Electrical issues are considered a hazard until repaired. I recommend repair as needed.

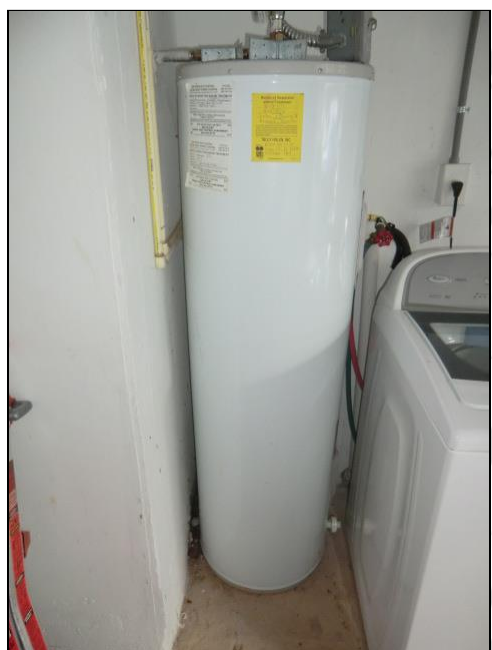
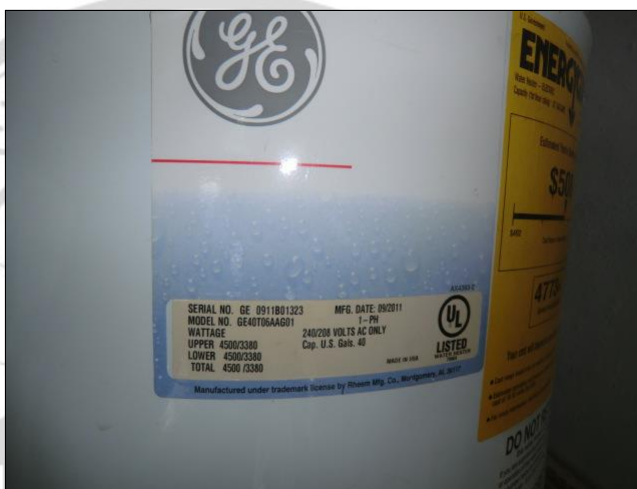
Water Heater

8.2 Good Condition. Manufactured year 2011

Manufactured year 2011

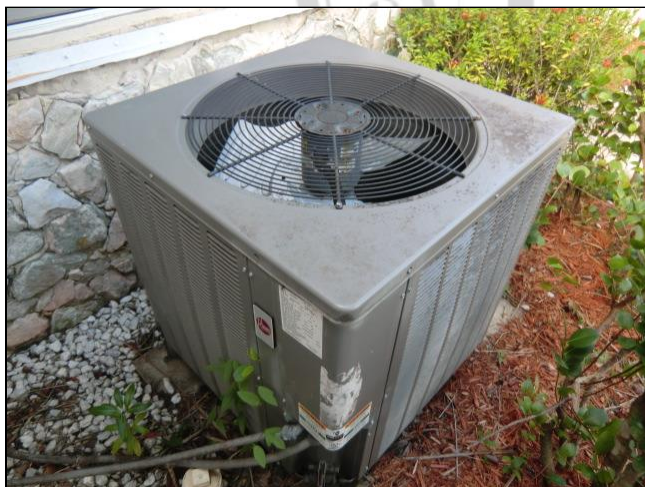
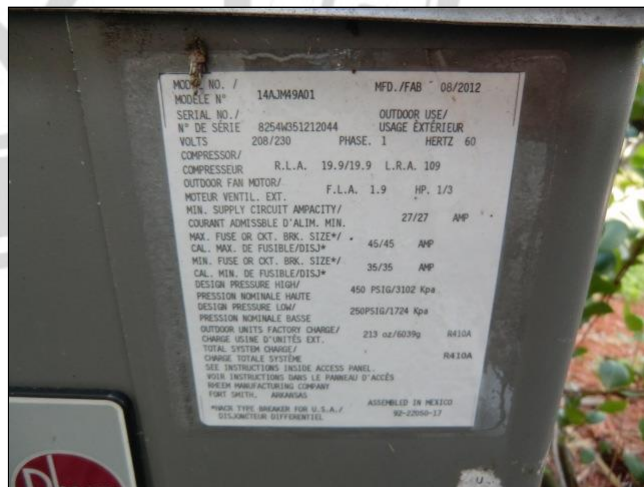
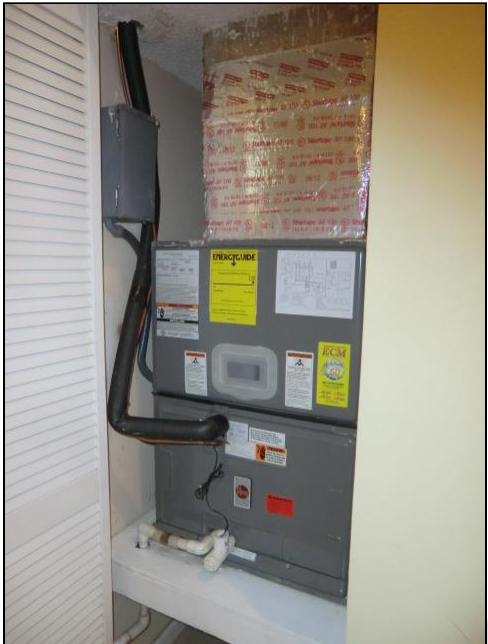
10.0 Good condition. Manufactured year 2012

The system worked as expected when tested and appeared to be serviceable at the time of the inspection. As with all mechanical equipment, the unit may fail at any time without warning. The inspector cannot determine future failures.

2012 AC condenser

2012 AC condenser label

2012 Air handler

Recommendation: To keep a good system performance and efficiency I recommend a HVAC contractor to service the whole system including Condenser, Air handler, gas, thermostat, etc. and repair or replace as needed.

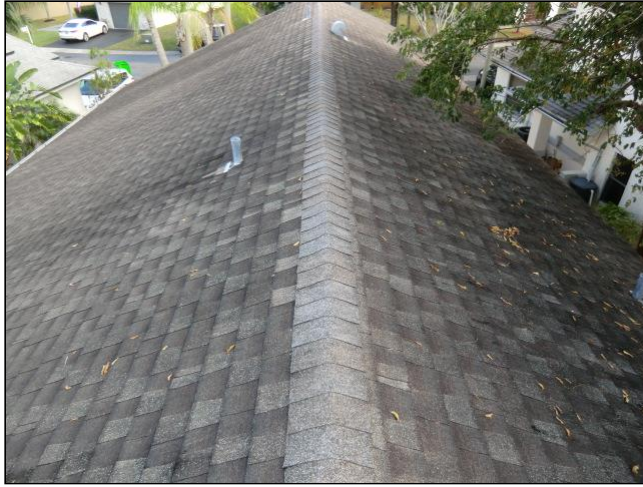
(1) Good Condition. Roofing permit done in May 23, 2005

Shingle roofing

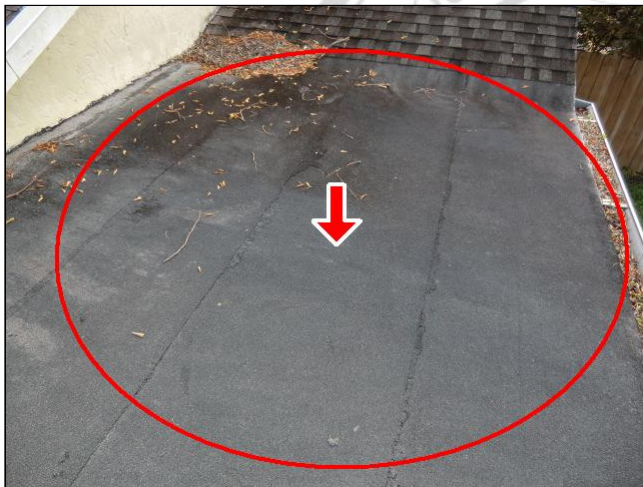
(2) **Defective**

Roller roofing shows some deterioration at the rear of home. I recommend to protect the roller roofing with a waterproofing elastomeric sealant coating to prevent leaks and extend remaining life. A qualified licensed contractor should inspect and repair or replace as needed.

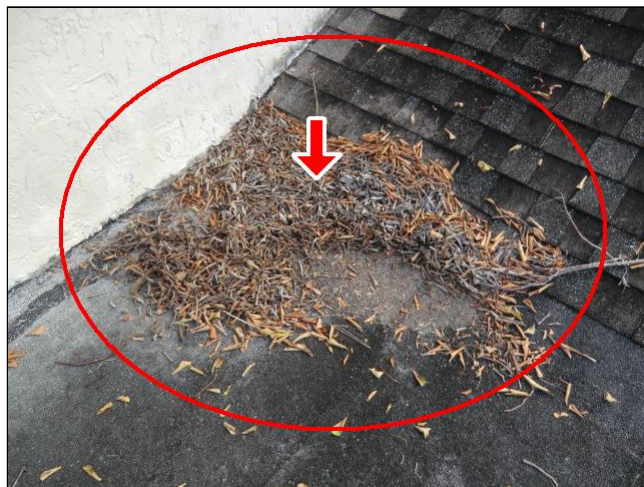
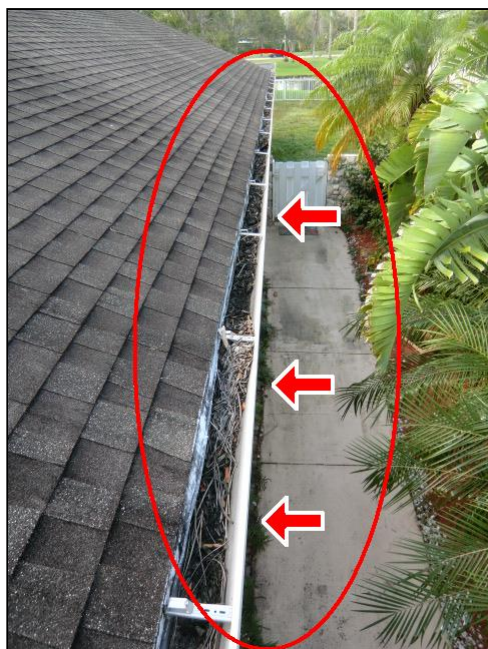
1.3 Roof Drainage Systems (gutters and downspouts)

(2) **Defective**

The gutters are full of debris in areas and needs to be cleaned. The debris in gutters can also conceal rust, deterioration or leaks that are not visible until cleaned, and I am unable to determine if such conditions exist.

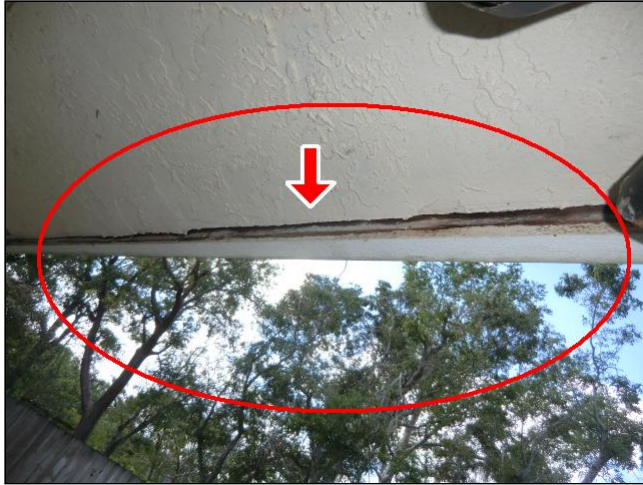
2.4 Eaves, Soffits and Fascias Inspected, Repair or Replace Defective

A gap between the fascia and roof sheathing exists which allows insects or bees to enter attic at the rear of home .
A qualified licensed contractor should inspect and repair or replace as needed.

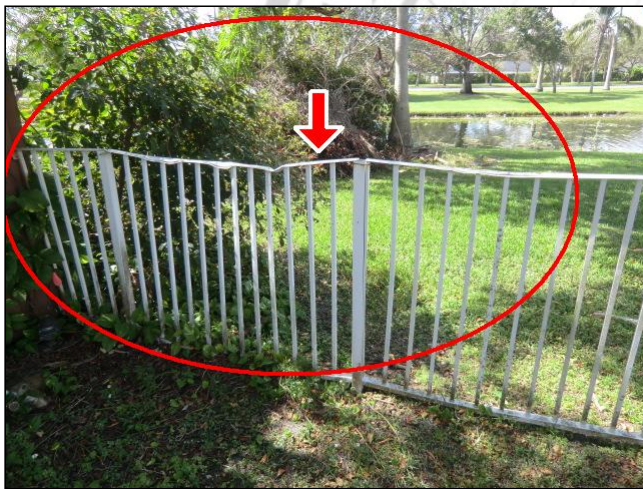
2.8 Fence

Defective

Metal fence shows some damage at the rear of lot. A qualified licensed contractor should inspect and repair or replace as needed.

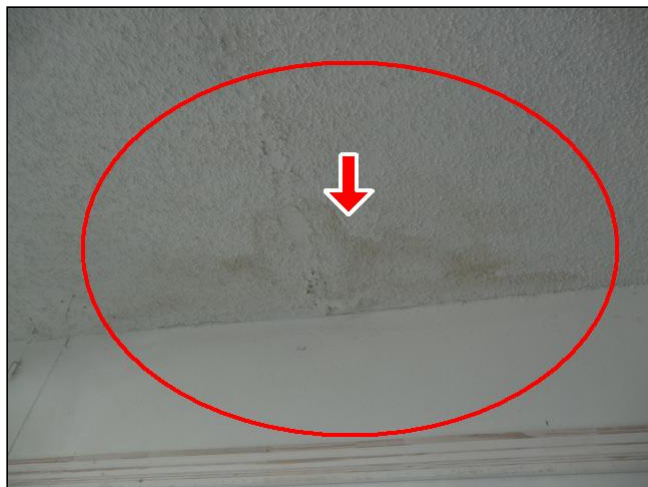
3.0 Garage Ceiling

Defective

The Texture on the ceiling reveals a light stain which appears from a water leak. Stain appears old at the garage. While this damage is cosmetic, it needs to be repaired. A qualified person should repair or replace as needed.

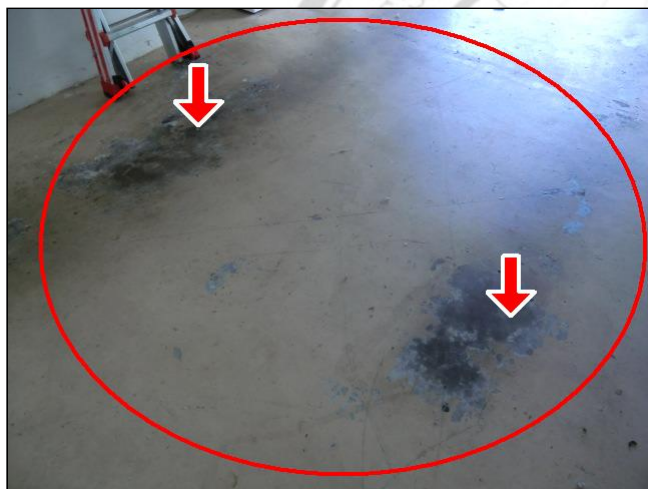
3.2 Garage Floor

Defective

The concrete floor of garage is peeling paint. A qualified licensed contractor should inspect and repair or replace as needed.

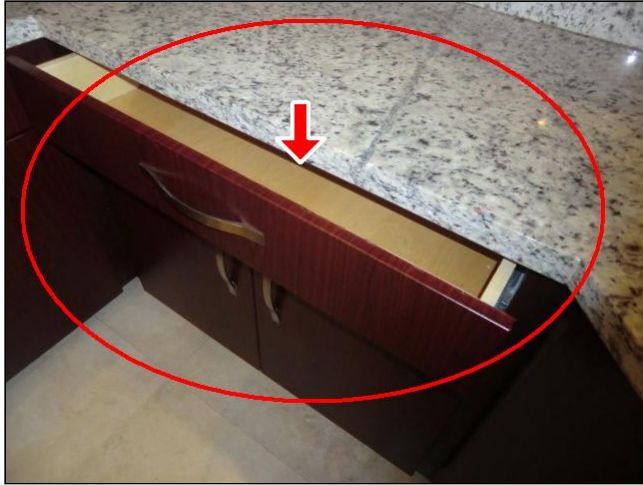
4.5 Counters and a representative number of Cabinets

Defective

Drawer track does not work smoothly (left of sink). This is a cosmetic issue for your information. Recommend repair or replace as necessary.

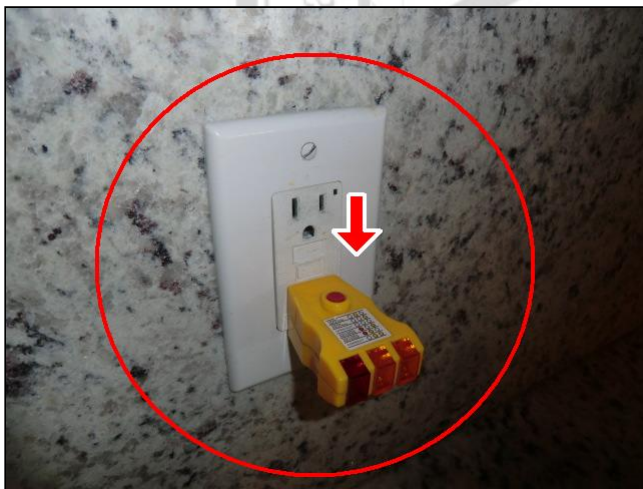
4.8 Outlets Wall Switches and Fixtures (Representative number)

Defective

At least One GFCI (Ground Fault Circuit Interrupter) outlet at the kitchen did not work or there is no power to outlet. Electrical issues are considered a hazard until repaired. I recommend repair as needed.

Estimated cost to repair or replace around \$50-\$150. Call contractors for estimate.

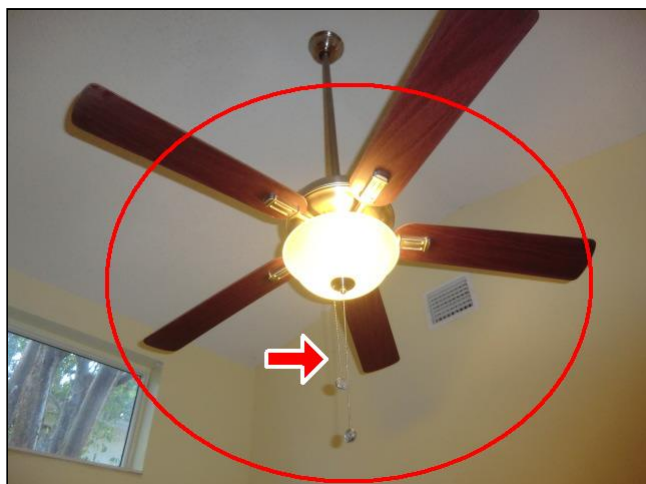
5.6 Outlets, Switches and Fixtures (Representative number)

Defective

The ceiling fan has the switch chain stuck at the Dining room. A qualified licensed contractor should inspect and repair or replace as needed.

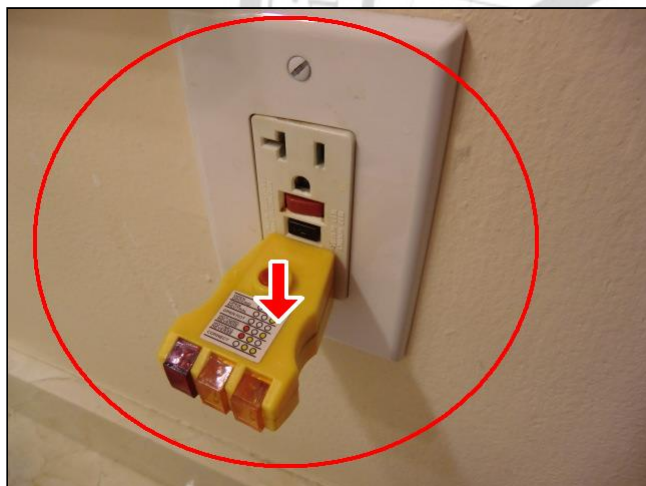
6.5 Outlets Switches and Fixtures (Representative number)

Defective

At least One GFCI (Ground Fault Circuit Interrupter) outlet at the hall bath did not work or there is no power to outlet. Electrical issues are considered a hazard until repaired. I recommend repair as needed.
